# FlightFax

REPORT of ARMY AIRCRAFT ACCIDENTS

November 1996 ♦ Vol 25 ♦ No 2

RECIPE  
for DISASTER

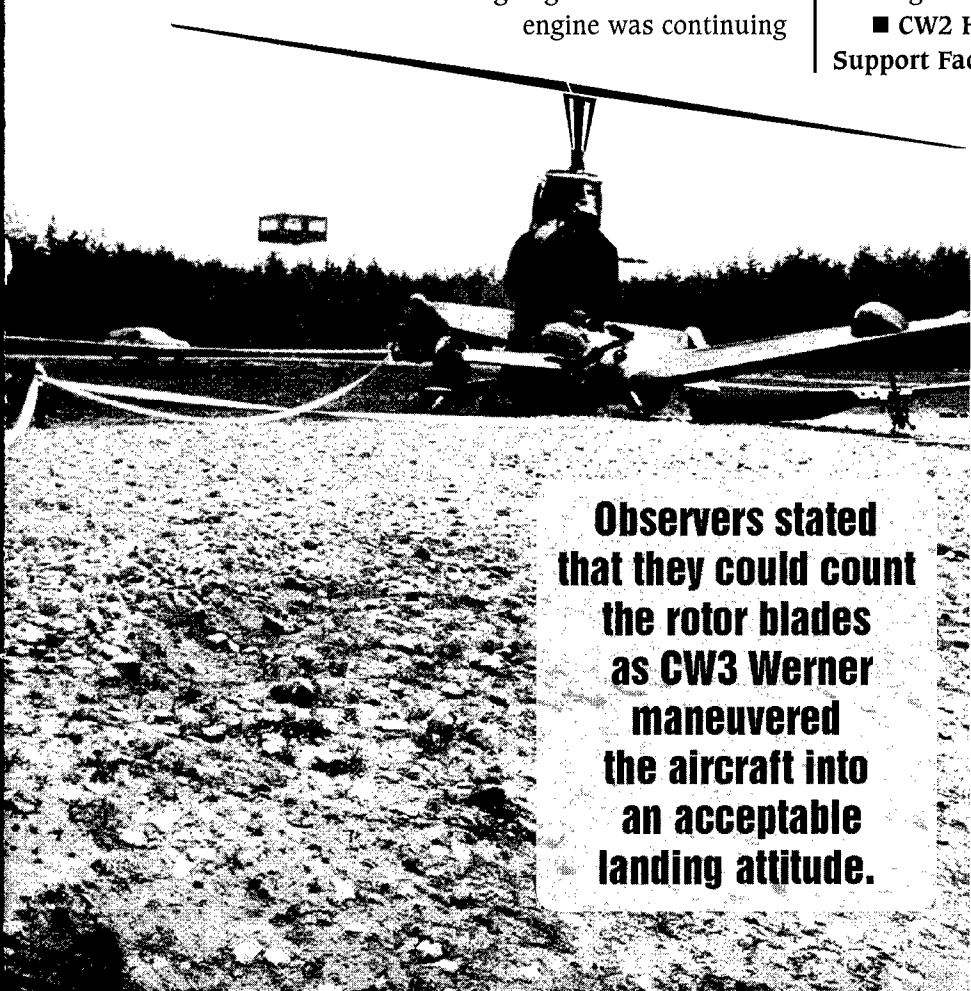
**Observers stated that they could count the rotor blades as CW3 Werner maneuvered the aircraft into an acceptable landing attitude.**

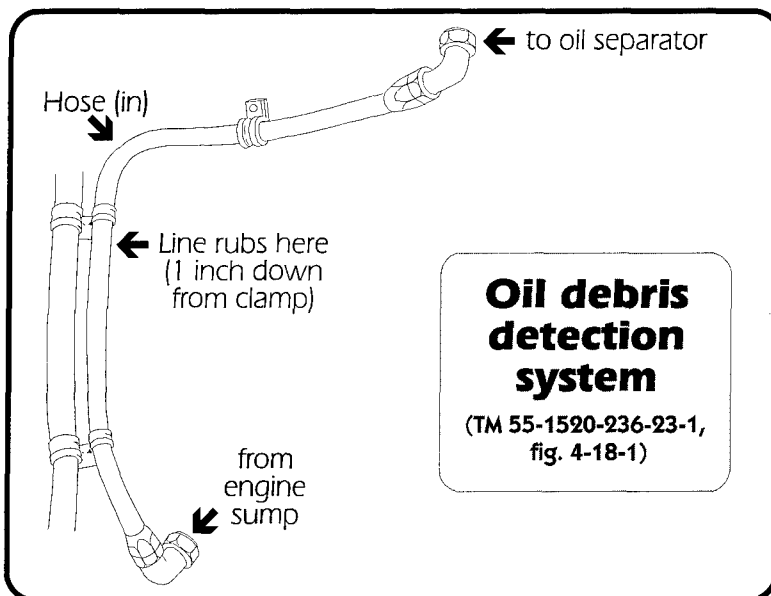
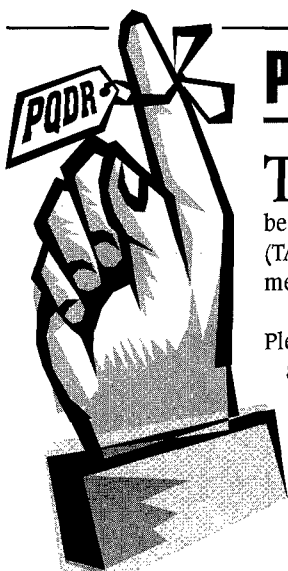
Recently, an oil line from the accessory gearbox to the engine oil debris detection system (ODDS) on an AH-1F ruptured in flight. Luckily, the aircraft, which was on an IFR training mission, was on short final when the line ruptured. Otherwise, this Class E mishap could have been much more serious.

Subsequent maintenance inspection found that the oil line had ruptured due to contact with the sharp edges of the flange on the improved particle separator (IPS) modification. The unit has found three other aircraft with the same problem and has had to replace the oil lines.

It'd be a good idea to inspect *all* AH-1s with the ODDS installed (MWO 55-1520-236-50-30) to ensure that the oil line is not rubbing against the IPS flange.
